## X'Air Airworthiness Alert

All Raj Hamsa X'Air and X'Air Falcon Owners

22<sup>nd</sup> July 2010

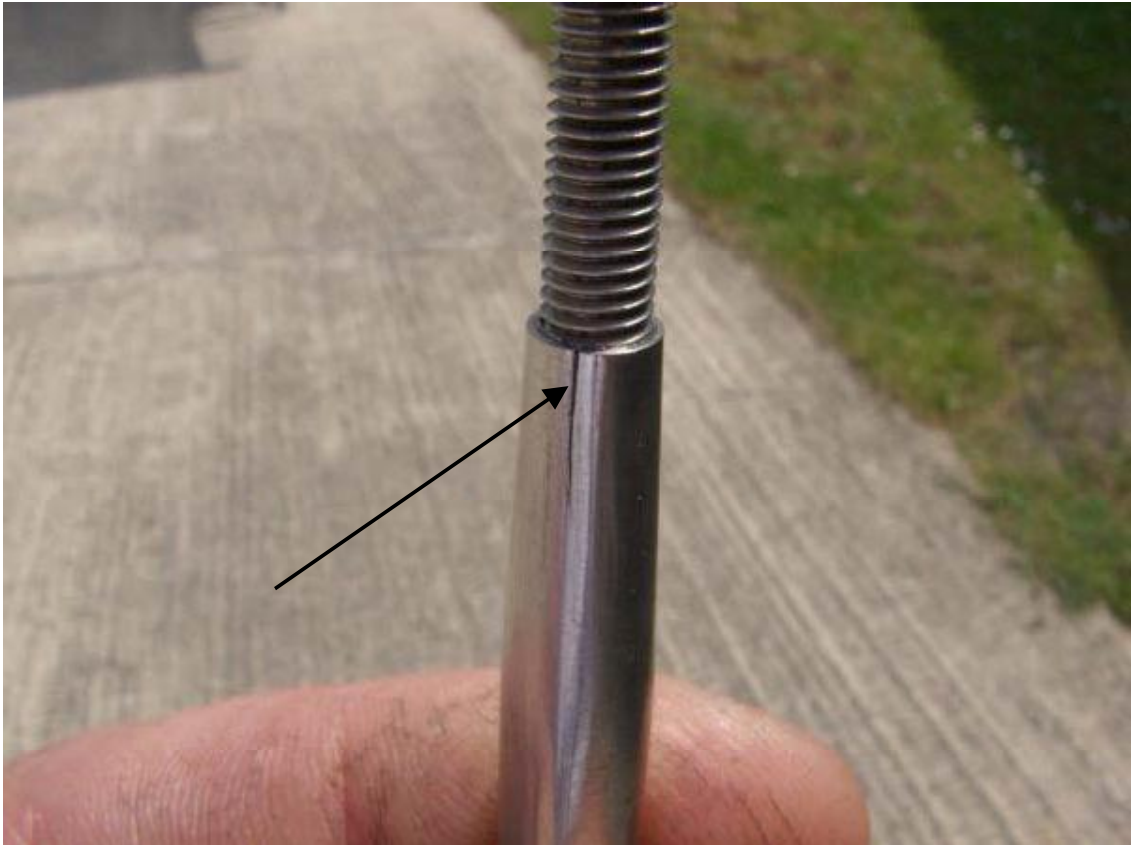
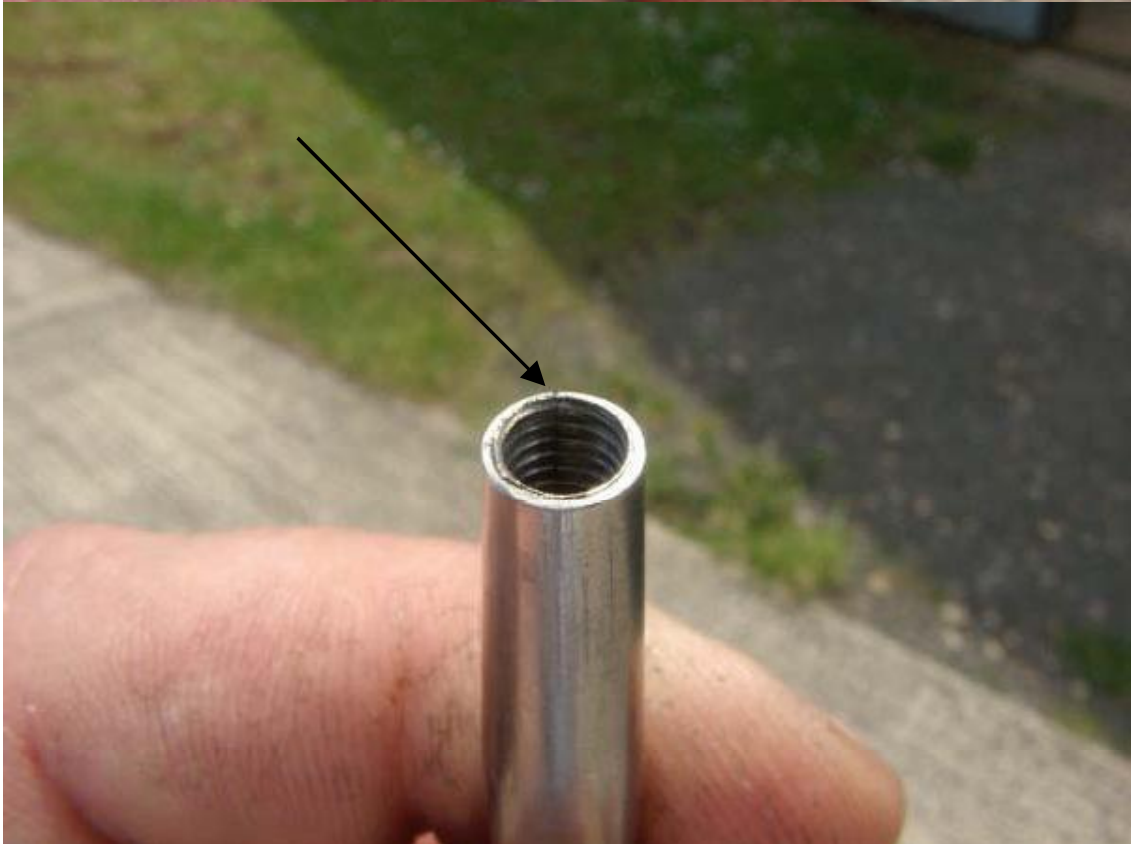
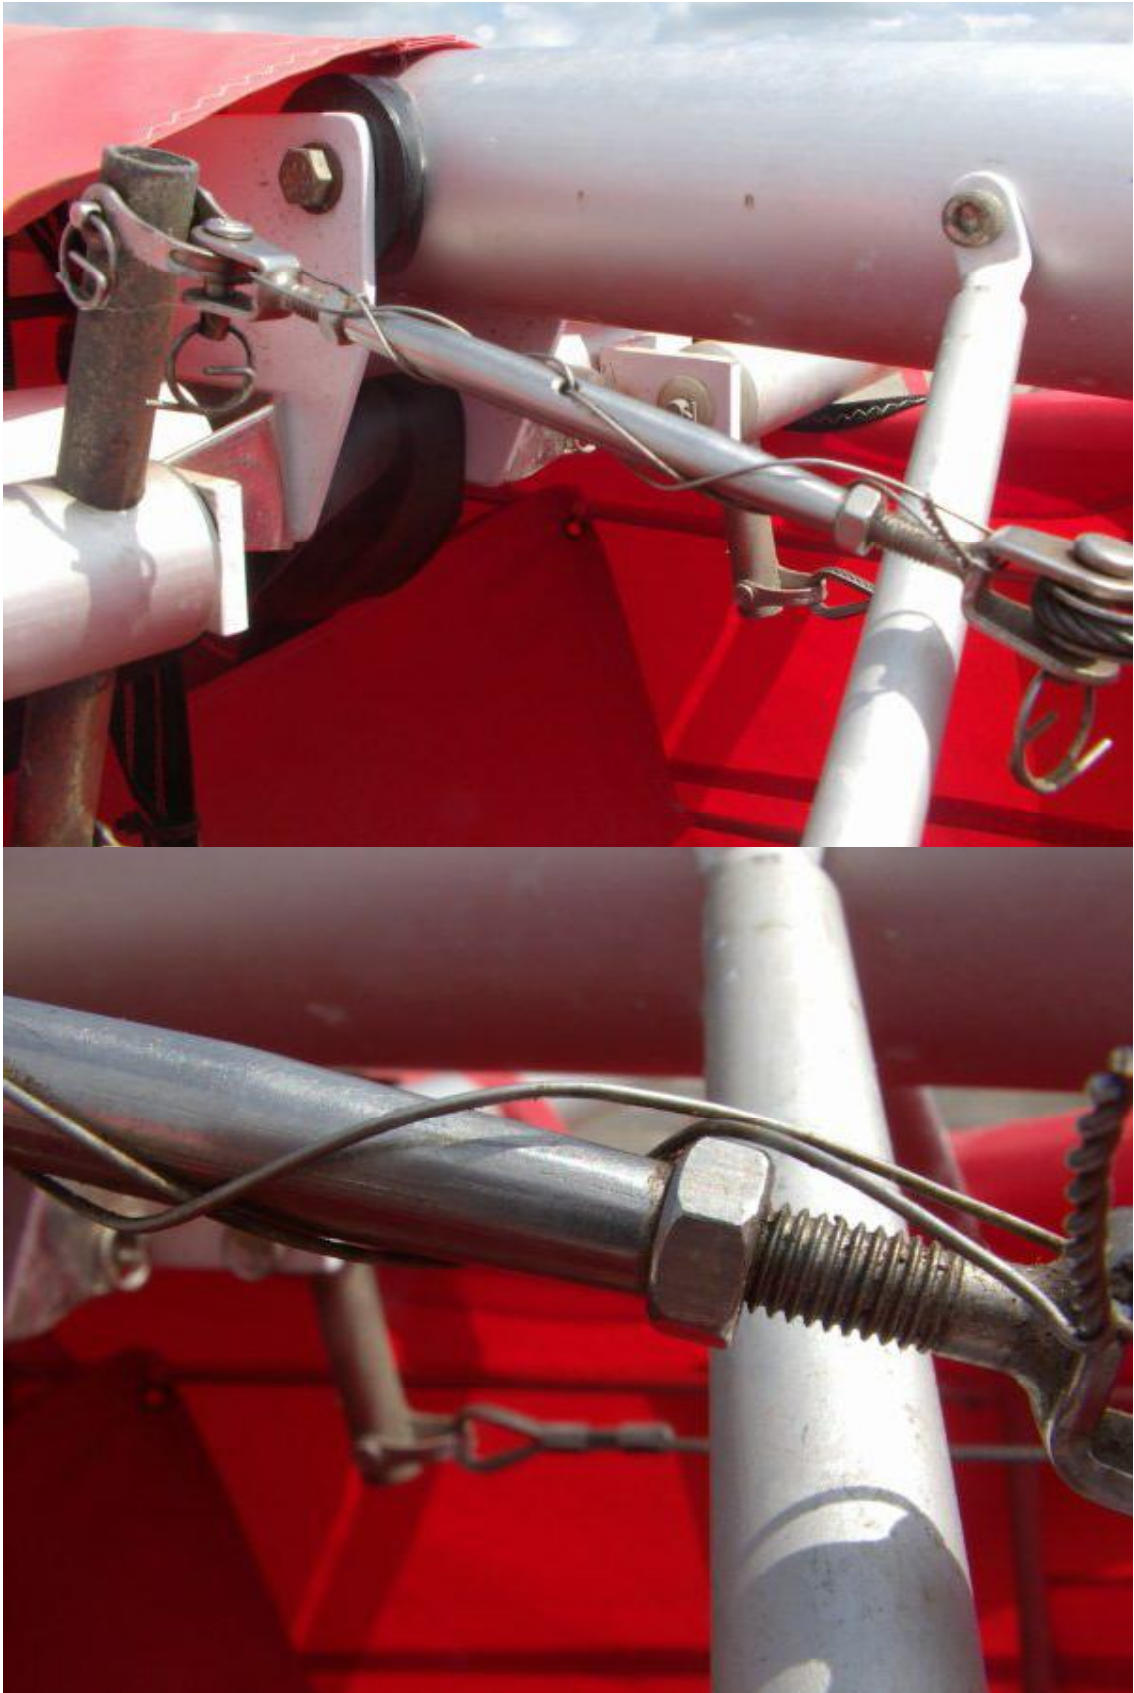
It was recently reported by one of our inspectors that an aileron turnbuckle on an X'Air had witness marks from the tooling / extrusion process. One mark appeared to have developed into a crack. Once the turnbuckle was removed and inspected it could be clearly seen that the crack went all the way through and for the entire length of the thread. See the accompanying images.

All the turnbuckles were different, as the tolerances seemed to vary considerably. The cracked one had a taper that made the threaded area very thin. This is from the manufacturing process and not from any wear or damage. New turnbuckles, sourced directly from X'Air, also have the manufacturing marks on them.

To inspect the turnbuckles they should be clean and well illuminated. Check the entire surface of each tapered end of both turnbuckles.

Look for any significant tooling marks and check each mark for a possible crack propagating from the end. If a crack is suspected remove the turnbuckle from the aircraft and then disassemble the suspect end for a closer look. Hold it up to a bright light to help identify a crack, and to check whether it penetrates right through the thread.

- o Add a careful inspection of the turnbuckle ends to your daily inspection.
- o Do not fly with a cracked turnbuckle. Replace with a new turnbuckle from The Wessex Light Aeroplane Company.
- o Refit the turnbuckles in accordance with the UK Build Manual.
- o Disturbed primary controls require a second inspection by a suitably qualified person before further flight.
